BMYS - Safe Harbour
Project

**Lanepiper Report –
Cliff geomorphology**

Our Ref: 209057LetterReport01.2

Cliff Face Slope Stability Assessment Beaumaris Motor Yacht Squadron, Beach Road, Vic

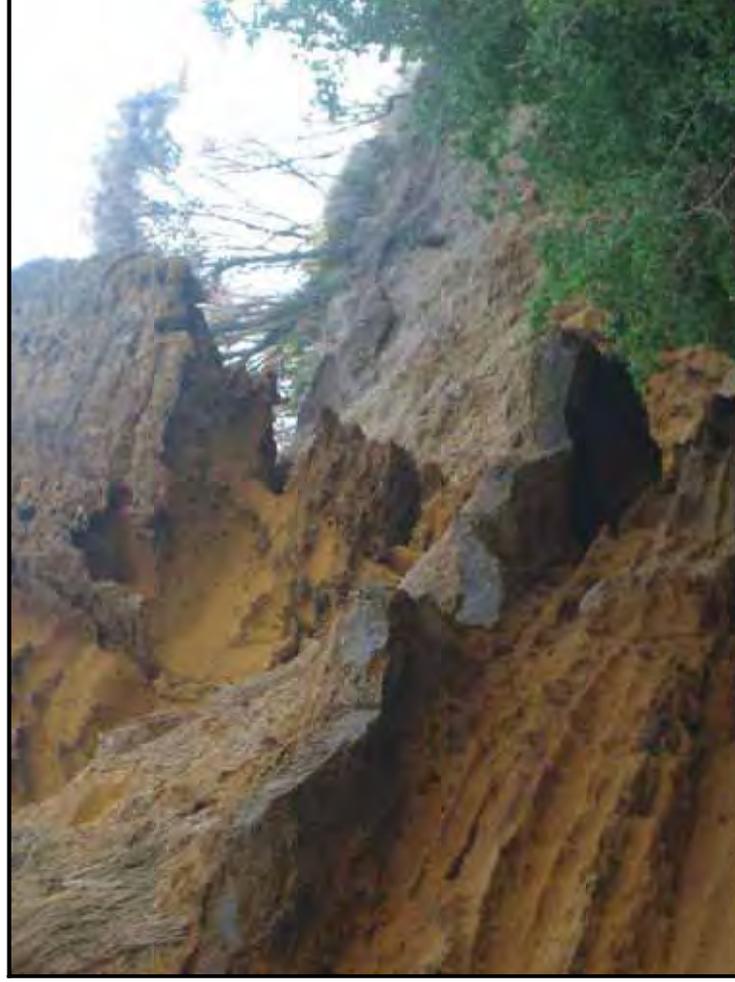
The cliff face in the area of the proposed dry stack structure, is typically near vertical and approximately 8 to 9 m in height. The rock is mostly massive and highly ferruginised, with prominent, near horizontal, ironstone bands in the lower half of the exposed face. The closely spaced, parallel ironstone layers are more erosion resistant than the surrounding sandstone matrix, and form a highly contoured profile in the cliff face (Figure 4-1).

Figure 4-1 Resistate ironstone layer exposed in cliff face

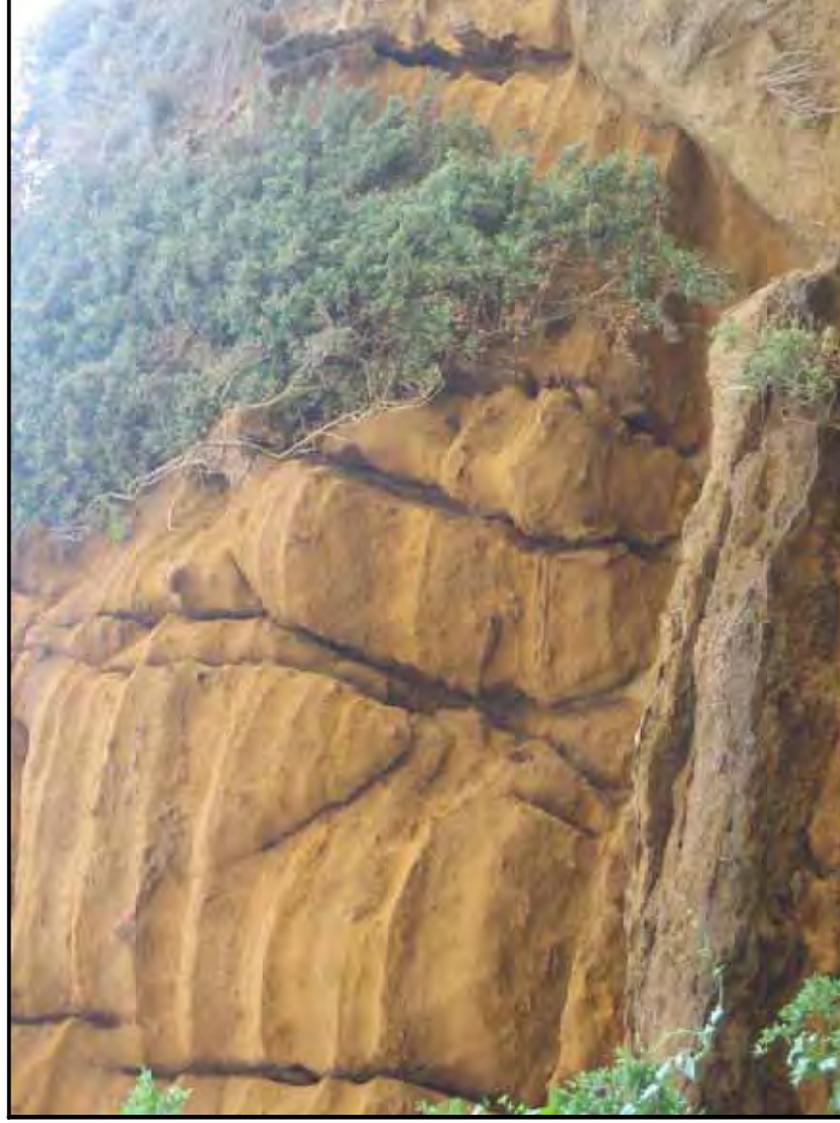
The runoff from the cliff top has been concentrated in channels forming near vertical rill erosion channels, which are typically 100 mm wide and 150mm deep, but in isolated areas are up to 500 mm deep (Figure 4-2).

Based on the inspection from the base of the cliff, the upper 1 m of the cliff appears to be unconsolidated sediments (i.e. clay, sand and silt), which are part stabilised at the exposure by the surface vegetation. Some of this vegetation has grown over and down the cliff and certain localities there are small trees growing from the cliff face.

Figure 4-2 Near vertical erosion channels and overgrown vegetation

The vegetation on the cliff face will, in most areas assist to stabilise the rock surface. However, on the near vertical cliff face, the growth of tree roots will encourage the dislodgment of the rock blocks.

The lack of a drainage channel on Beach Road above Section 1 has potential to allow runoff during heavy rainfall events, onto the reserve area and over the cliff edge. This will help erode the surface soils and fractures, swelling and softening of the clays within the joints, and exacerbate the rilling in the cliff face. It is recommended the local Council construct a kerb and channel with associated drainage along Beach Road, or even better on the cliff side of the bike track, in the area of Section 1, to minimise runoff over the cliff face. The collected runoff should

be piped and discharged to sea. We recommend that the Club encourage the Council to do these works.

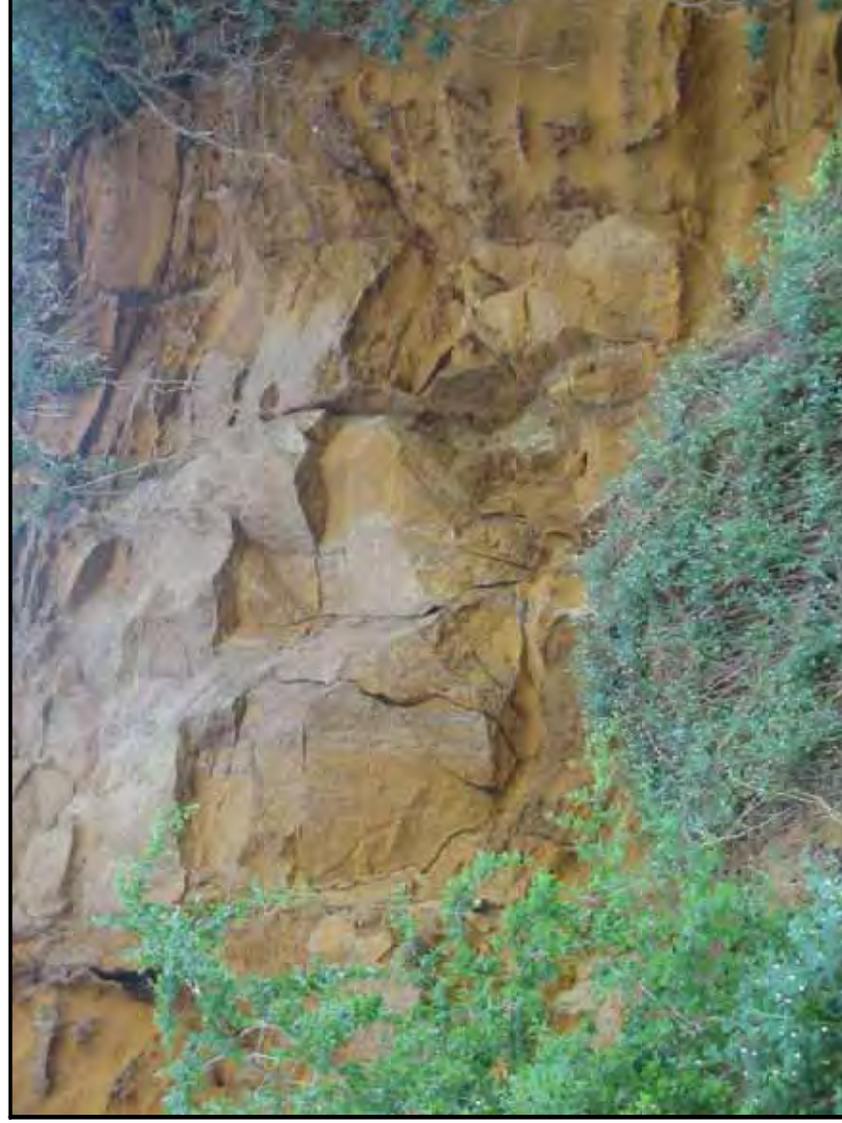
Figure 4-3 Fractures in cliff face

In isolated areas, there was fracturing and tension cracks evident in the rock. The fracturing is generally identified from the rilling, by the more angular surfaces and the non-linear and variable orientation of the failure surfaces, some of which extend into the cliff face, creating wedge shape blocks of variable size Figure 4-3. Above the BMYS fence which runs perpendicular to the cliff, near the eastern end of the site, there is one such large wedge shaped block, which juts out from the cliff face. The rilling and fracturing are mostly confined to the upper half of the cliff face, above the ironstone layers.

Based on the recent inspection, the cliffs exposed along the Beaumaris Motor Yacht Squadron site are overall in a relatively stable condition. However, there was evidence of fracturing, and tension cracking of the sandstone, particularly in the upper half of the cliff towards the eastern end of the site, which has created wedge shape blocks. Over time the cracks will propagate, partly due to water ingress, erosion and weathering, making the blocks less stable until eventually the block topples from the face. The vertical rilling does not appear to compromise the integrity of the cliff, but does result in debris at the toe of the cliff.

It is recommended that any loose blocks and large overhangs be removed from the cliff face to reduce the potential danger to the public and members of the Yacht Squadron. Care needs to be taken with this work to only remove the sections in imminent danger and not loosen other sections of the cliff face. The dangers should be highlighted with increased signage. However we do not consider a need for this work at this time, but on-going assessment of the cliff face is required.

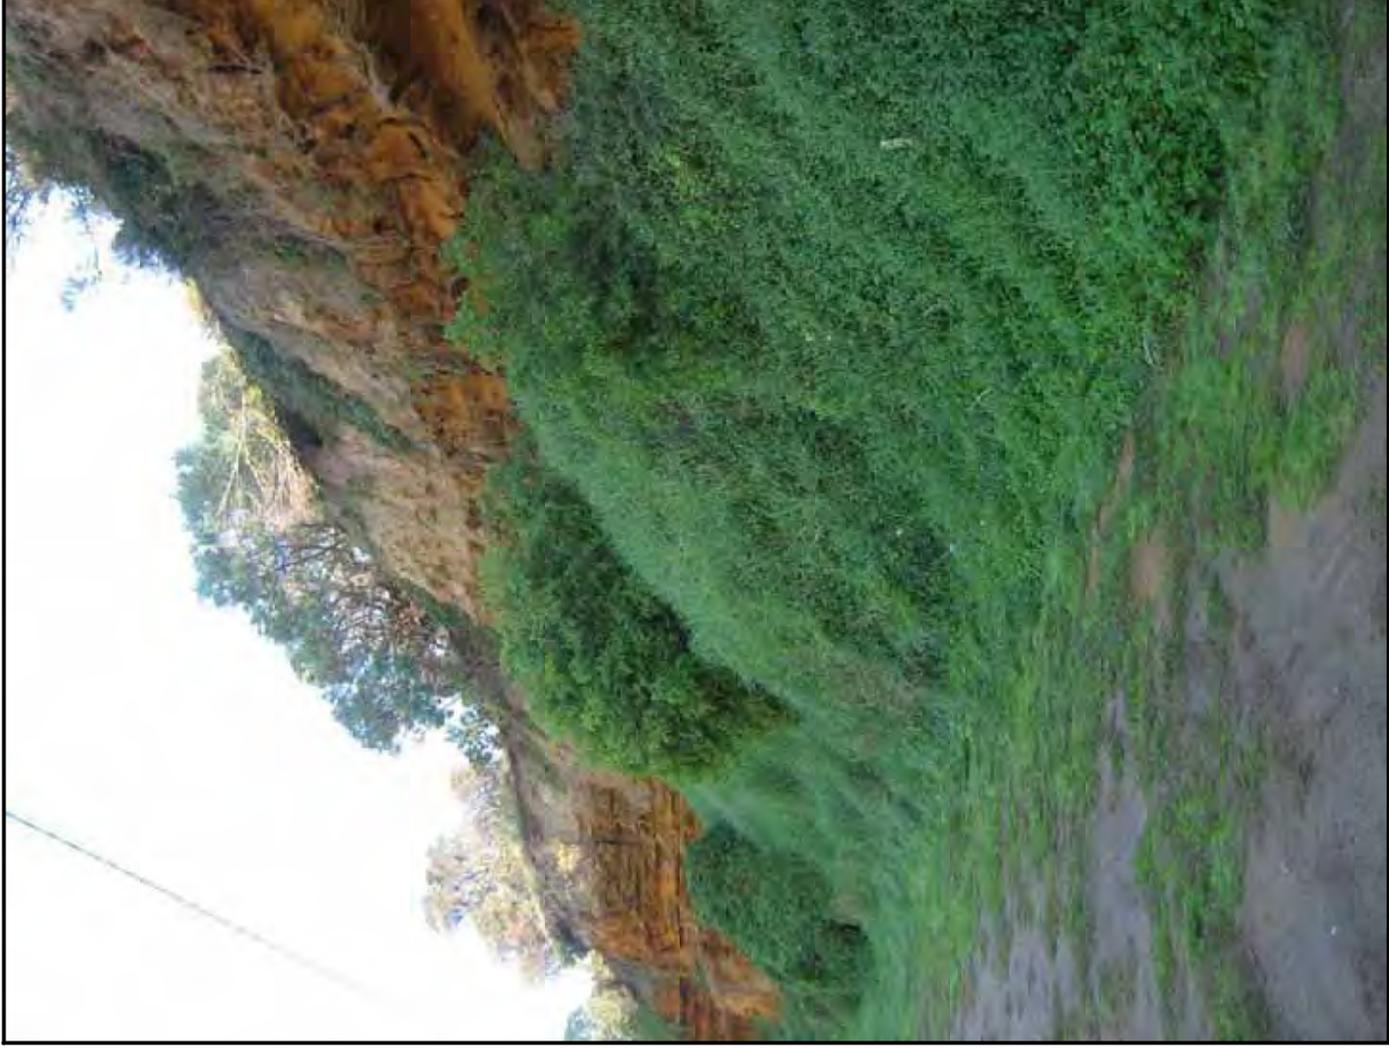
Figure 4-4 Accumulation of talus at base of cliff

On the seaward side of Beach Road, above Section 1, there was a kerb but no channel. Runoff from the top of the cliff has washed soil down the cliff face. In areas where the cliff face forms ledges, the soil has accumulated. Along the toe of the cliff, there is considerable accumulation of heavily vegetated debris (talus), from the cliff. Mostly the talus is steeply sloping and reaches to nearly half way up the cliff face in places (Figure 4-4). No surface water, or groundwater seeping through the cliff face was detected during the site inspection, however, the inspection was conducted on dry day.

It is recommended a rockfall wall be integrated into the rear of the proposed drystack structure, to help protect the boats and the drystack structure itself. The wall would typically be of precast, reinforced concrete construction. Prior to construction works for the dry-stack structure, it is recommended the debris along the toe of the cliff, in the area of the dry-stack structure be cleared.

The rockfall wall section should be at least 3 m high and be designed to accommodate the accumulation of rock debris, up to 2 m high between the cliff and the wall. The structural designer of the dry-stack structure will need to allow for this active pressure from the debris accumulation, as well as impact loads from the debris, which could be blocks or finer fill erosion. Care must be taken during construction of the dry-stack structure, to ensure that the machinery used is kept away from the cliff face as much as practicable, to ensure loose blocks do not get dislodged from the cliff, and endanger the plant operators or construction workers.

The BMYS needs to periodically inspect and remove the accumulation of cliff debris behind the dry-stack structure, and the cliff face, to ensure the ongoing effectiveness of the rockfall wall. During the removal of the debris, a 'spotter' should be engaged to ensure the safety of the operator and ensure that the machinery does not cause further falls. The debris needs to be removed before the debris accumulates to greater than 1 m depth up the rockfall wall (i.e. there is at least 2 m of rockfall wall above the debris).

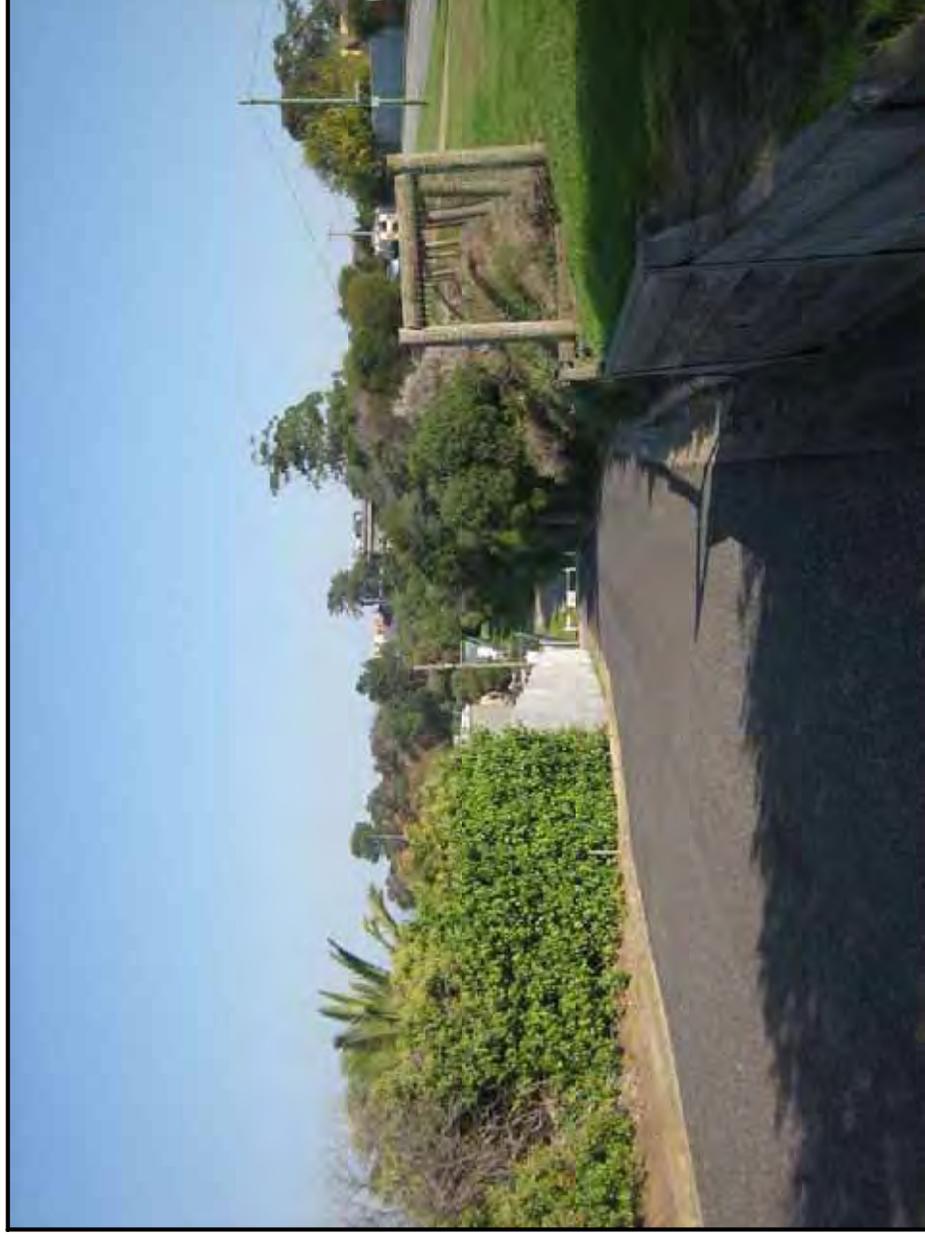
Overall, there was no evidence of any instability in the area of Section 2, other than minor creep movements identified by the subtle bulging out of the retaining wall and dipping of the fence posts. However these minor movements are expected to be attributed to the inadequate supports for the retaining wall, rather than global instability of the embankment. ..

Figure 4-5 View down access road to BMYS site and ROW
