**Cnr Reserve & Balcombe Road, Beaumaris**

## **Arboricultural Construction Impact Assessment**

**Thursday, 24 November 2016**

Ref: 4068 161208 CIR Stewart Cnr Reserve & Balcombe Beaumaris Rds

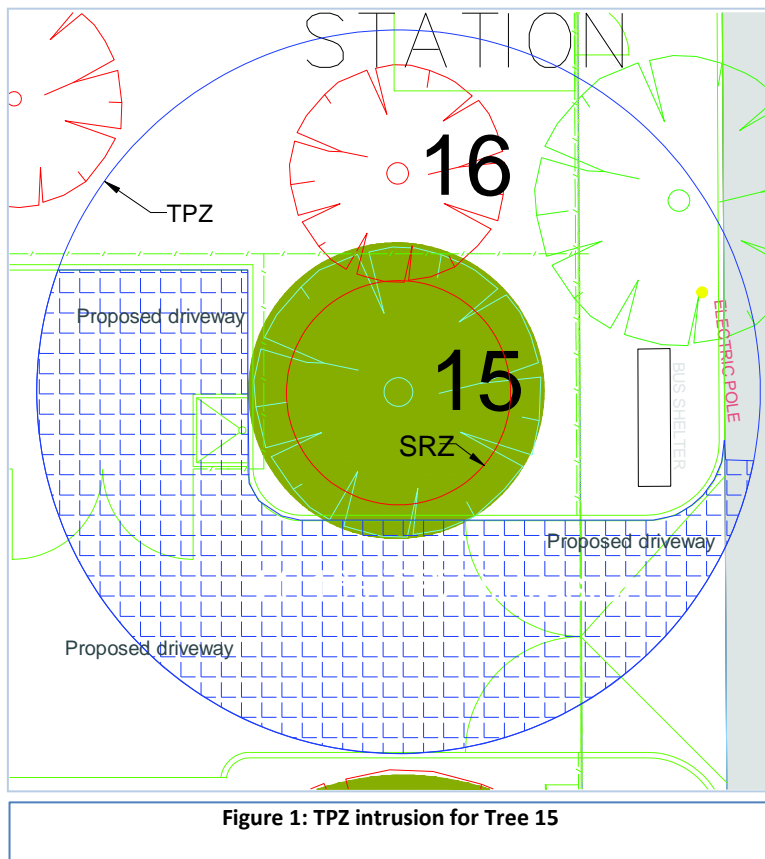
A crossover and driveway is proposed to be constructed to the east of this tree, occupying approximately 41.1% of this tree's Tree Protection Zone (TPZ) – Figure 1.

This tree has sufficient contiguous soil for to compensate for the proposed intrusion.

**Provided the recommendations of this report can be adopted and effectively implemented, this tree will remain viable alongside the proposed development.**

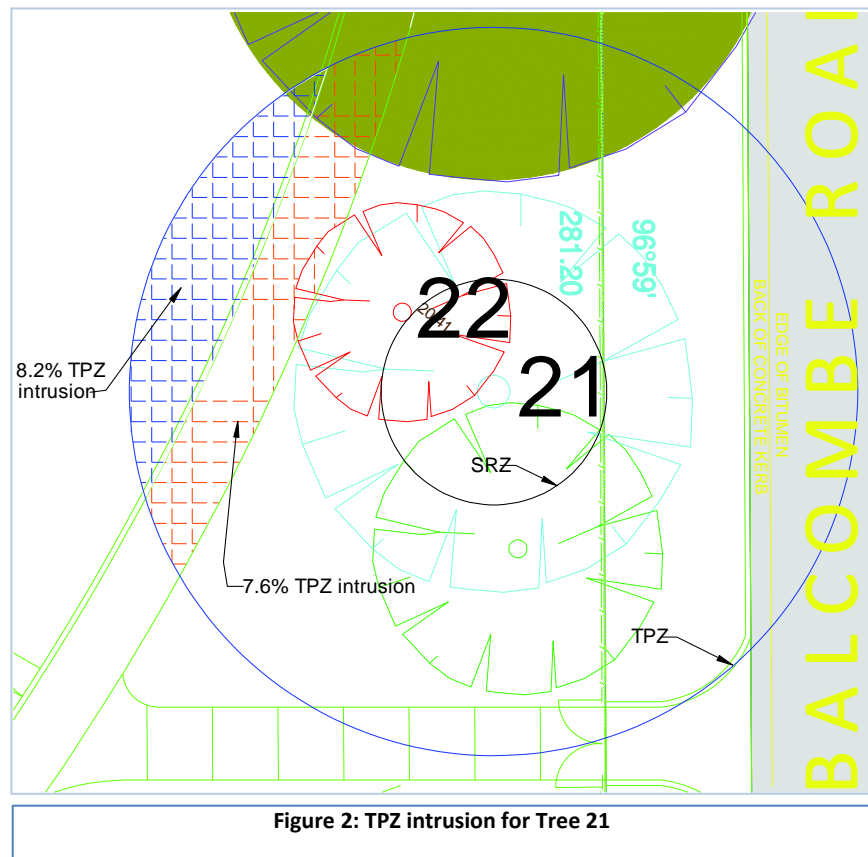
Given that a considerable section of this tree's TPZ is occupied by the poor growing conditions beneath Balcombe Road, it is likely that the tree has an asymmetrical root plate, with a higher proportion of roots in the area of the proposed oval to the south of the tree.

Given that the tree is expected to have a higher proportion of its root mass within this area, it would be advisable to avoid excavation within this trees TPZ, and install the irrigation outside of this area.

If possible, the sprinkler systems should be directed into this area to allow the watering of turf without requiring the destruction of tree roots present within this area.

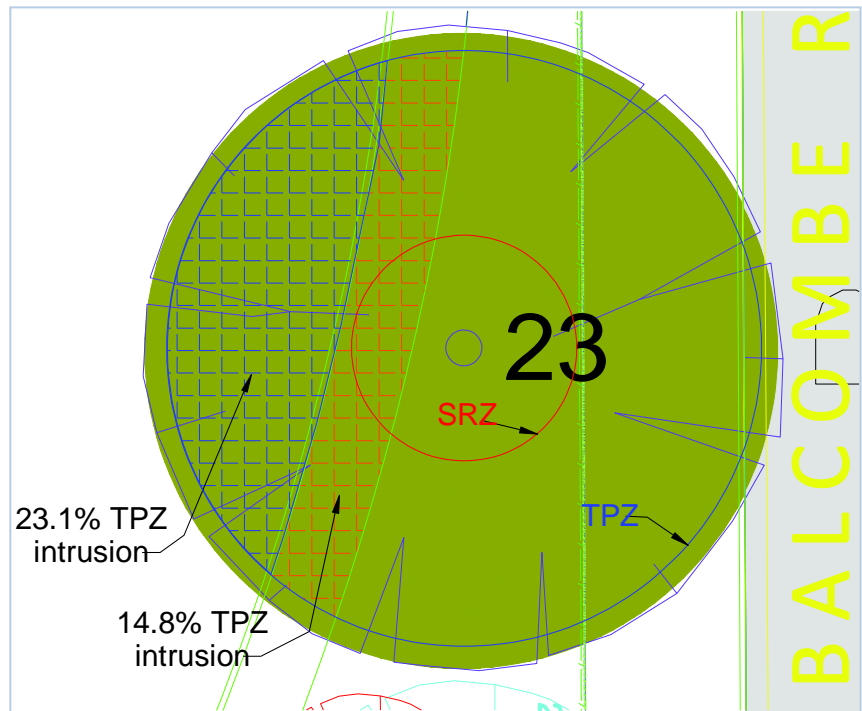
Figure 3: TPZ intrusion for Tree 23

However were this excavation to be excluded from within the TPZ and any sprinklers required for watering turf be directed into this area from outside the TPZ, this tree would be expected to tolerate the impact to its roots system.

**This tree will remain viable within the proposed development provided the recommendations of this report can be adopted.**

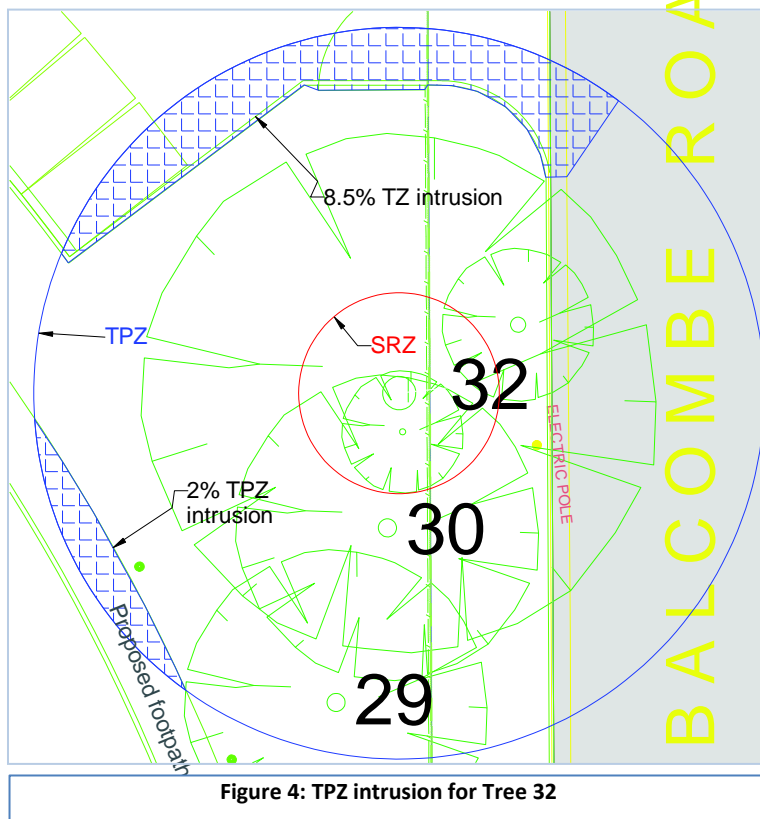
Figure 4: TPZ intrusion for Tree 32

It is proposed that a carpark be constructed to the west of the tree, and a footpath be installed to the south.

Should neither of these options be selected, the tree will not remain viable alongside the proposed car park and should be removed.

Measures would be undertaken to protect against soil compaction and root damage, such as Geoweb cells per earlier recommendations.

**This tree will remain viable alongside the proposed development provided the recommendations of this report are adopted and effectively implemented.**

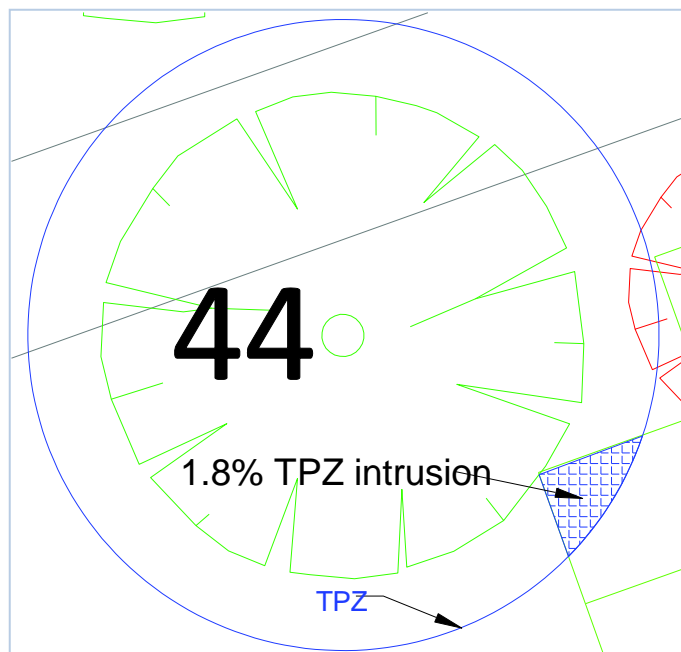
Figure 6: TPZ intrusion for Tree 44

Under *AS4970 (2009) Protection of Trees on Development Sites* this is considered a minor intrusion, and will not significantly impact the health or longevity of this tree.

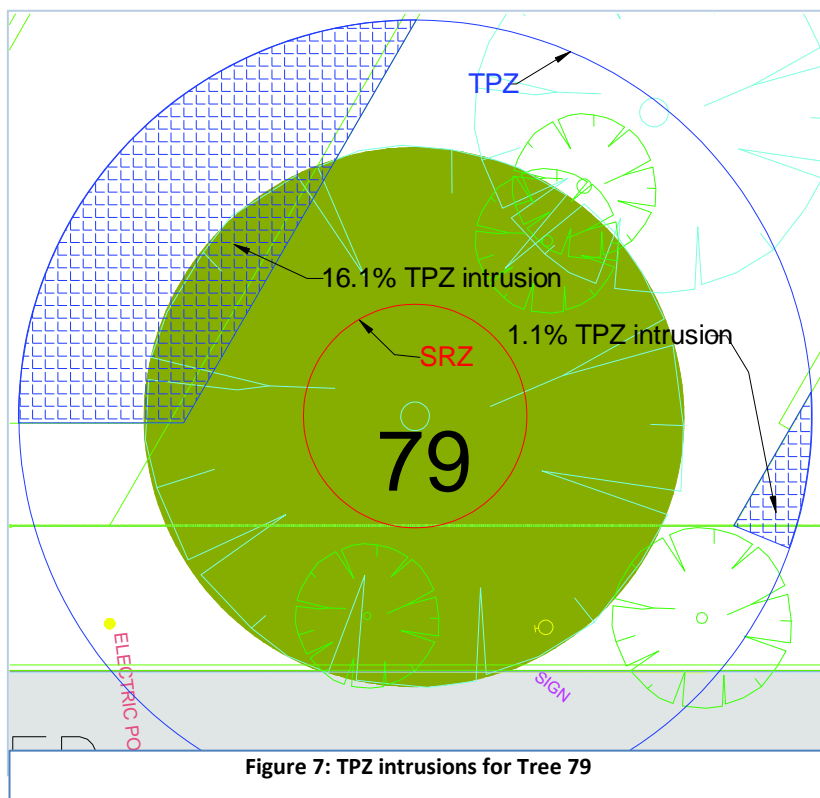
Figure 7: TPZ intrusions for Tree 79

Retaining walls to the north and south of this tree will occupy approximately 17.2% of this trees TPZ (Figure 7).

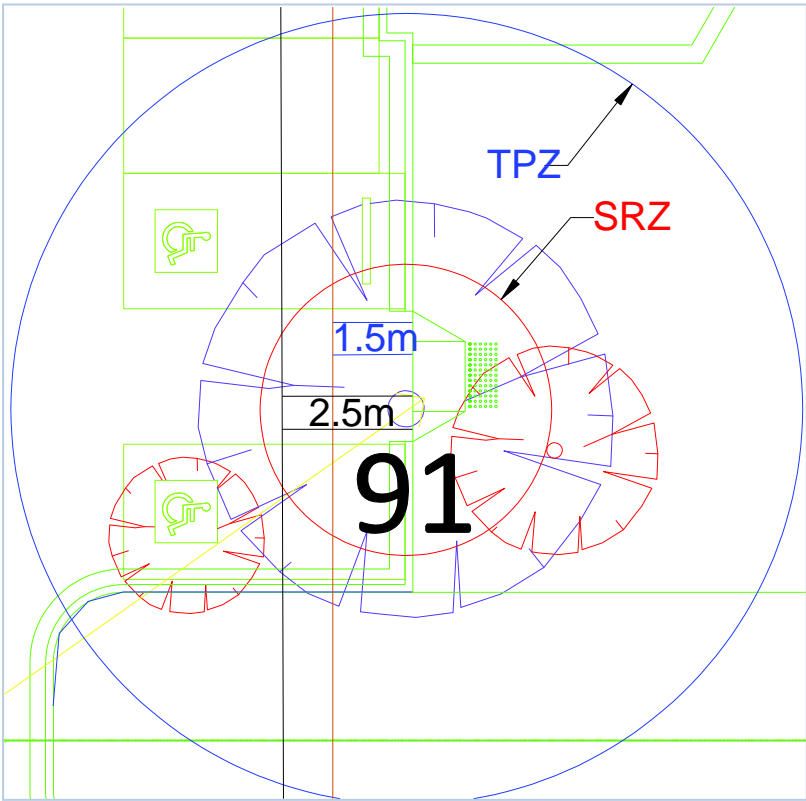
Figure 8: TPZ intrusion for Tree 91

However, were the soccer pitch to the south be reduced in size as to allow to carpark to move a minimum of 2.5 metres to the south, then root sensitive construction methods could be adopted to ensure the viability of this tree.

A permeable Geoweb system (or similar) should be placed over the areas of TPZ and be constructed upon to reduce soil compaction, and to allow the movement of water and oxygen into the soil.

**Provided the recommendations of this report are adopted and effectively implemented, this tree will remain viable alongside the proposed development.**

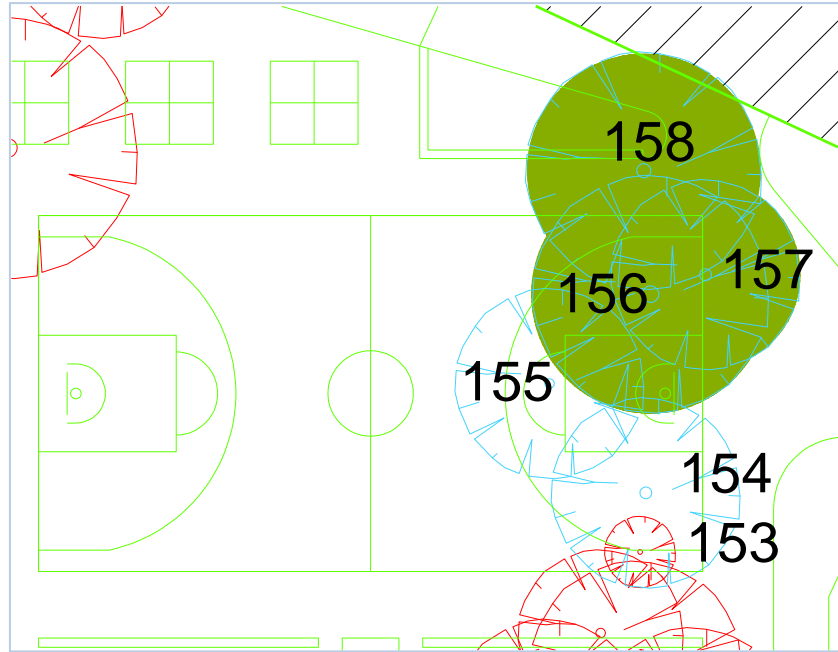
Figure 9: Original plans

Under the original plans these tree lay within the footprint of the proposed netball court, or the adjacent retaining wall and could not be retained (Figure 9).

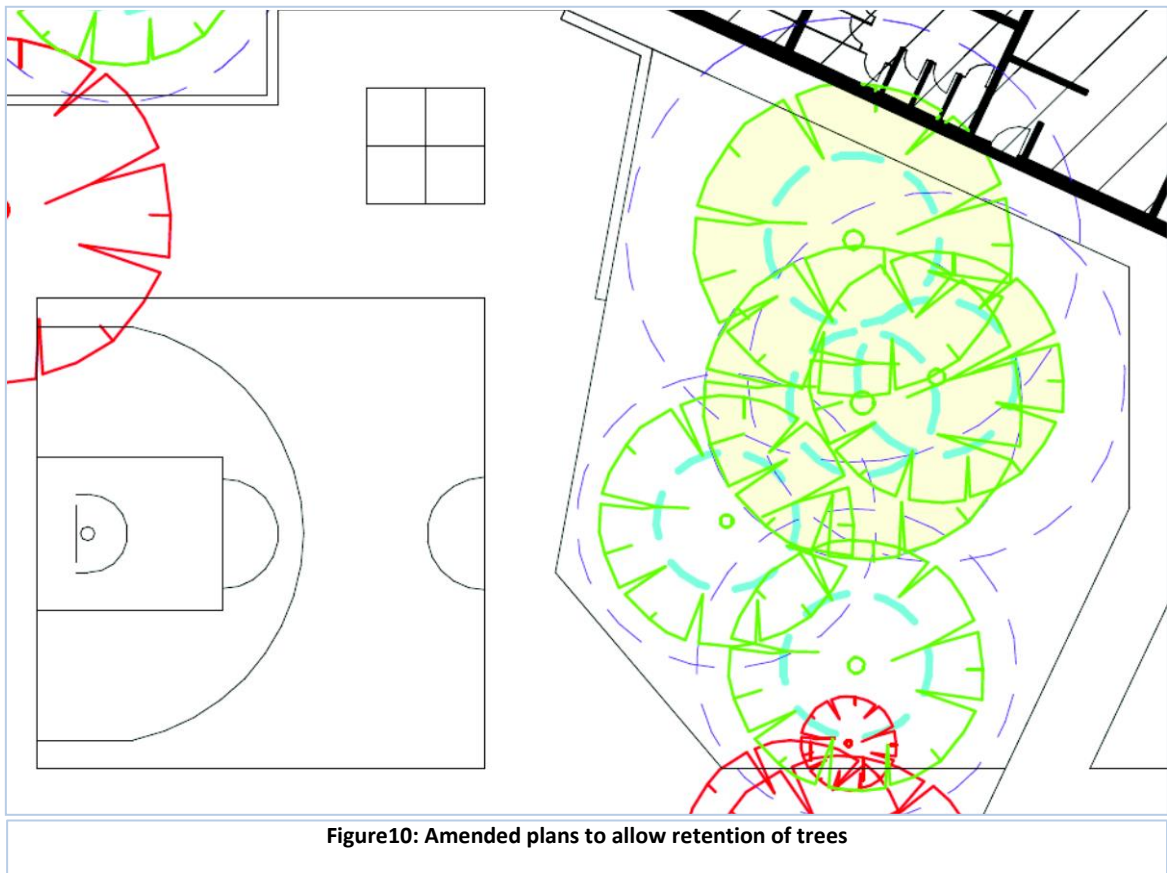
Figure 10: Amended plans to allow retention of trees

This redesign will allow for the retention of these Red Gums as no change to grade will be required, and the retaining

wall has been relocated (Figure 10).

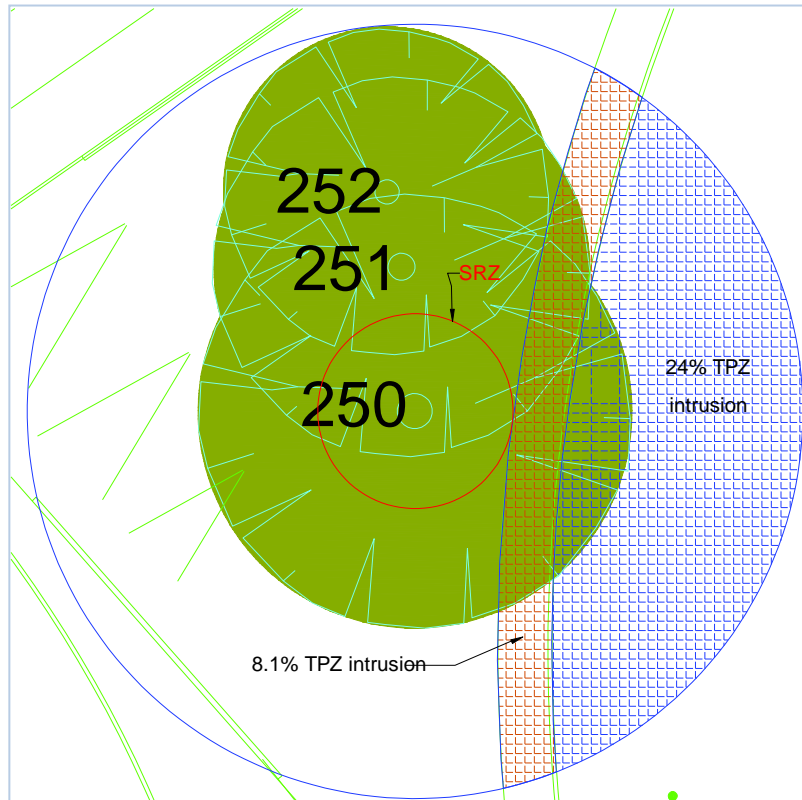
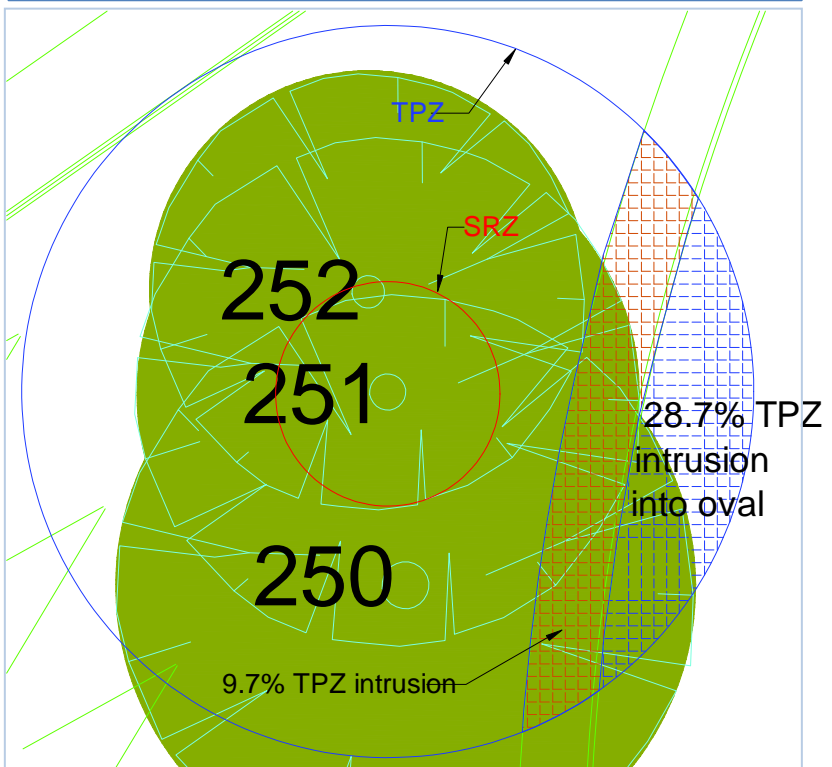
It is currently planned that the oval be excavated to a minimum depth of 0.5 metres to allow the installation of irrigation systems.

The removal of the roots within the soil profile will likely have a detrimental effect upon the health and longevity of these trees.

Figure 11: TPZ intrusion for Tree 250

Figure 129: TPZ intrusion for Tree 251

Should the excavation take place outside of the TPZ's of these trees, they will remain viable alongside the installation of the oval.

If possible, it is advised that any turf within the TPZ of these trees could be serviced by sprinklers facing inwards towards them, thus removing the need for root damage.

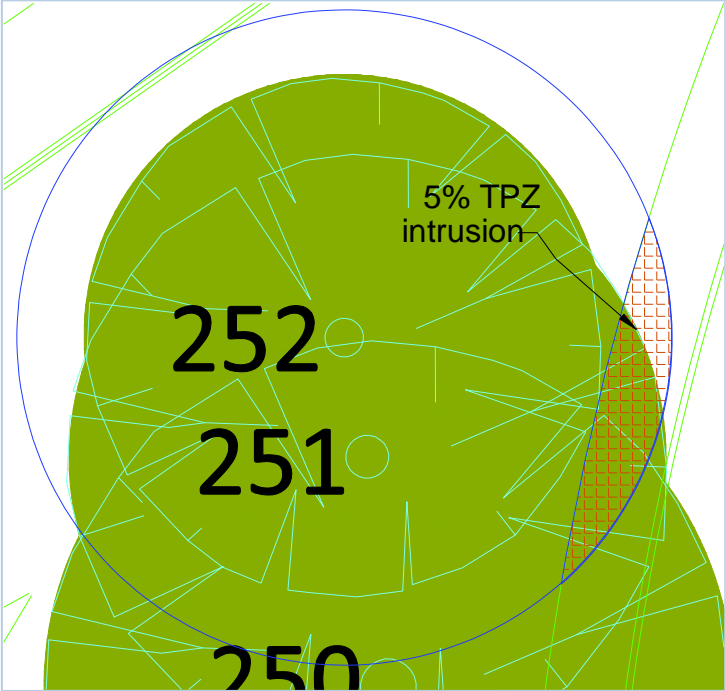
Figure 10: Tree 252 TPZ intrusion

Under *AS4970 (2009) Protection of Trees on Development Sites*, this is defined as a minor intrusion and is not expected to impact significantly upon the health or longevity of this tree.

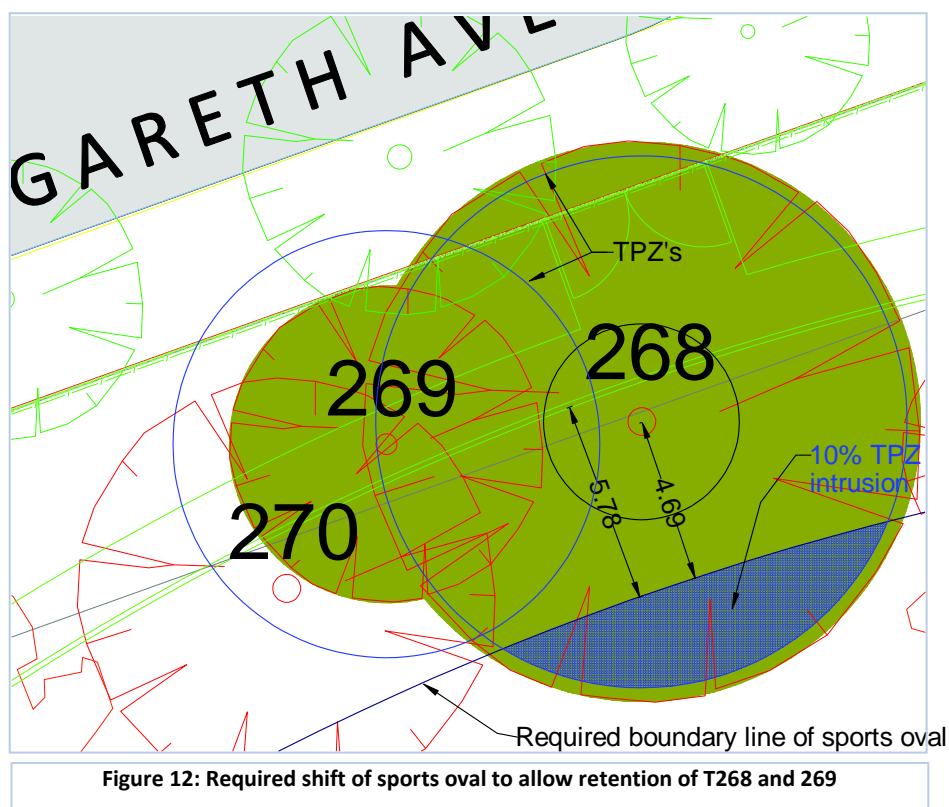
The suggested relocation of the oval would reduce the impacts to T268 to approximately 10%, and see no impact to the TPZ of T269.

Figure 12: Required shift of sports oval to allow retention of T268 and 269

However should the outer boundary of the sports oval be moved approximately 5.8 metres east by either shrinking or moving the footprint of the oval as illustrated in Figure 12, these trees could be retained alongside the proposed development.

Provided that no excavation greater than 100mm is required in the construction of the oval, the oval will need only be required to clear the Structural Root Zones of these trees. In this case the oval would only need move approximately 3.9 metres to clear the SRZ of T268. Should excavation deeper than 100mm be required in the construction of the oval this will not be a viable option.

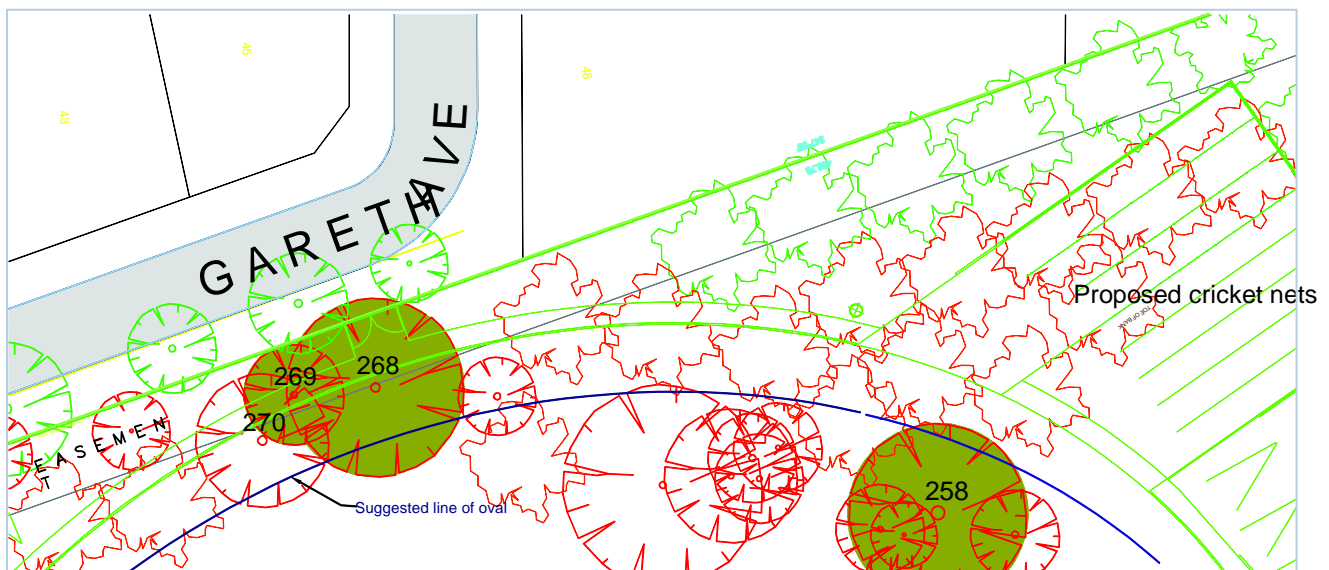
Many of these are proposed to be removed and are marked in red in Figure 13.

Figure 13: Tea Trees proposed to be removed (red) and retained (green) at Gareth Ave frontage

There are many Tea Trees not marked on the plans provided. Accordingly the tree locations in Figure 13 are used as a guide only.

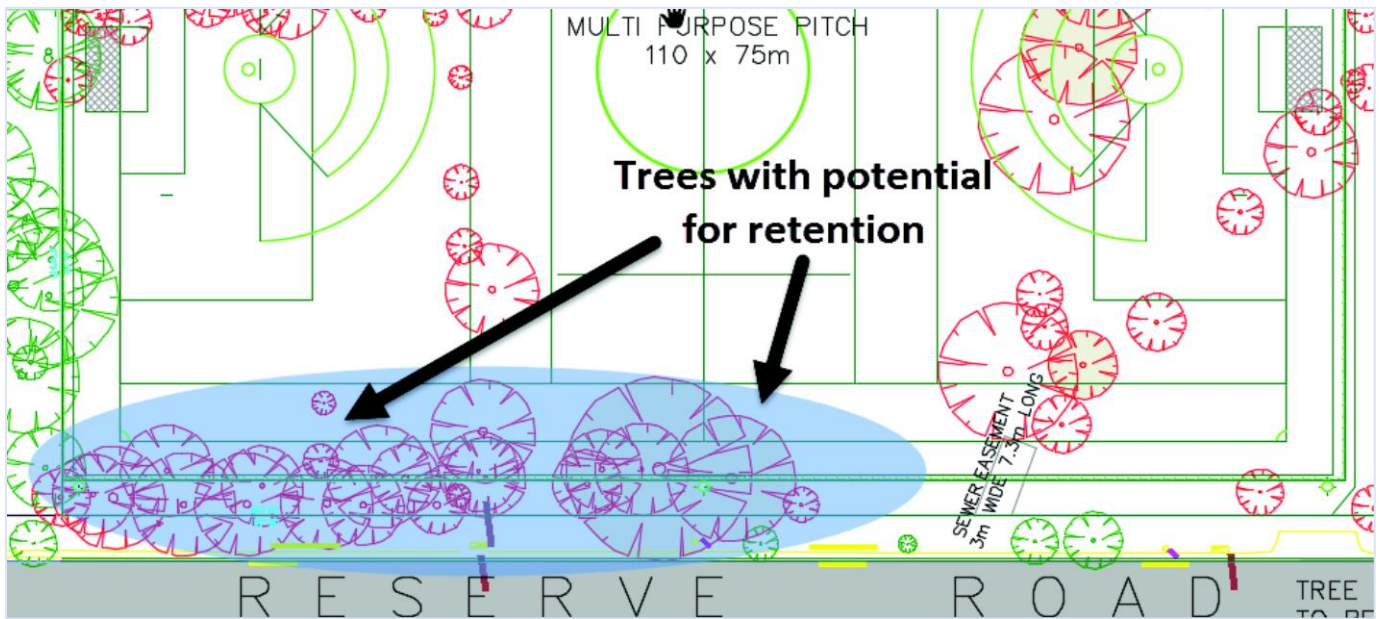
It is proposed that a multi-purpose pitch be constructed immediately to the west of or directly upon these trees (Figure 14).f

Figure 14: Tree with potential to be retained at Reserve Road Frontage

No data has been recorded detailing the dimensions and TPZ measurements of these trees. As such precise set-back requirements could not be determined to establish the distances required to ensure the viability of each tree. However based on a visual estimation of tree sizes and the locations of the trees shaded blue in Figure 14, a *minimum* set-back of 3 metres from the currently proposed eastern border of the multi-purpose pitch would be required to retain the smaller trees.
