BMYS - Safe Harbour
Project

**Lanepiper Report –
Cliff geomorphology**

Our Ref: 209057LetterReport01.2

Cliff Face Slope Stability Assessment Beaumaris Motor Yacht Squadron, Beach Road, Vic

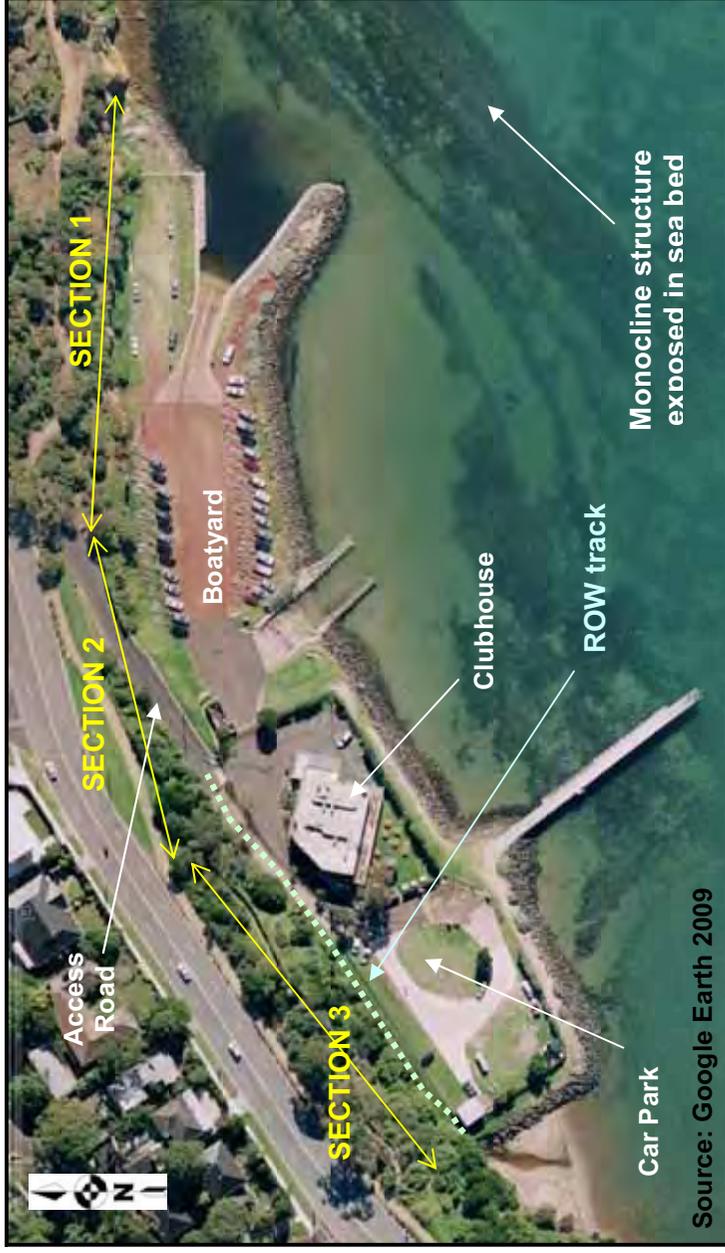
Figure 2-1: Aerial Photo of BMYS Site

The cliffs are aligned parallel to the axis of a major tectonic structure known as the Beaumaris Monocline, which has downthrown the sedimentary strata to the south-east. The parallel rock strata are striking north-west to south-west, and can be seen exposed in the seabed (see Figure 2-1).
