**Cnr Reserve & Balcombe Road, Beaumaris**

## **Arboricultural Construction Impact Assessment**

**Thursday, 24 November 2016**

Ref: 4068 161208 CIR Stewart Cnr Reserve & Balcombe Beaumaris Rds

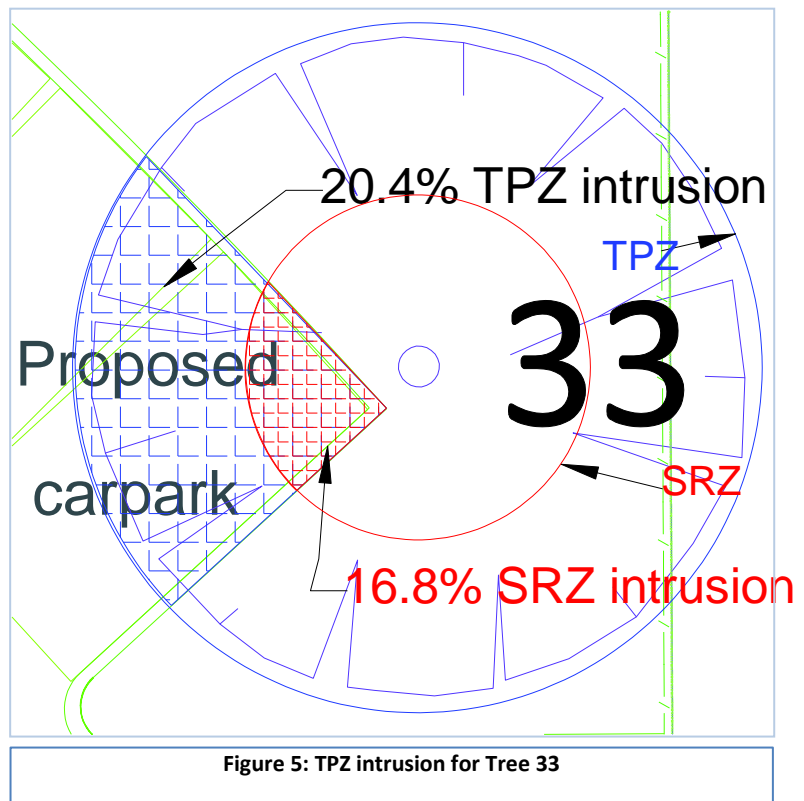
**This tree will remain viable alongside the proposed development provided the recommendations of this report are adopted and effectively implemented.**
